PROJECT PROFILE Newport Beach Vacation Property

DECK SAVER SYSTEM

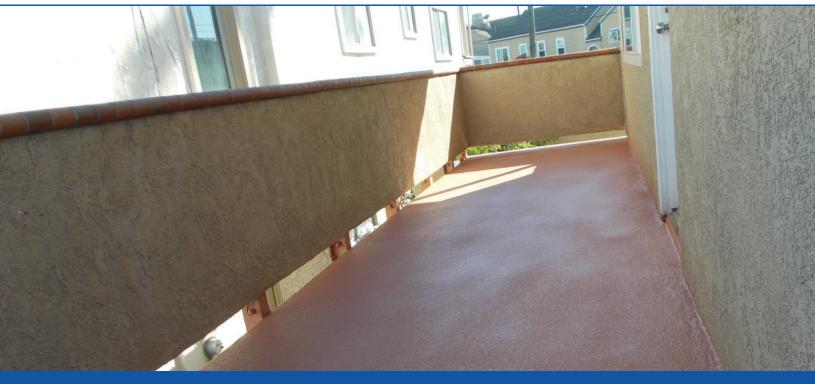
This Newport Beach vacation rental property was experiencing leaking and issues with their 350 SF high-traffic wood framed deck. The building owner chose the SureCoat Deck Saver System because it remains flexible, has a superior waterproofing technology beating any other existing system in the field, can be quickly cleaned and top-coated to keep the system looking brand new and can be easily repaired if necessary. The **SureCoat Deck Saver System** is ideal for existing decks requiring restoration, maintenance or repairs. It is a single component system which is easy to install and maintain.

The contractor replaced water damaged plywood at the intermediate deck landing including areas around drains and between support joists, then installed new deck drain flanges and covers, tied them into the existing PVC drain lines, and restored the deck using the SureCoat Deck Saver System. This system was used to restore the deck, eliminating costs associated with removal and disposal and minimized noise, mess and interruption of day to day operations. After repairing cracks and blisters on the deck and stairtread surfaces, the newly repaired landing areas were waterproofed with **SureCoat** and **SureCoat Poly-mesh reinforcing fabric.** The remaining deck and stairtreads were cleaned with **SureSkrub** and then top coated with our **Terra Cotta Cream StrucSureCoat** for a "like new" finish.
